# Vacuum pump Mercedes Benz diesel

## Damage due to wear on the cam disk

**SERVICE  
INFORMATION**

<b>Vehicle: Mercedes Benz</b>	<b>Product: vacuum pump</b>
Various models from model year 1968 with diesel engine	PIERBURG No.: 7.20208.../7.20547.../7.20607...

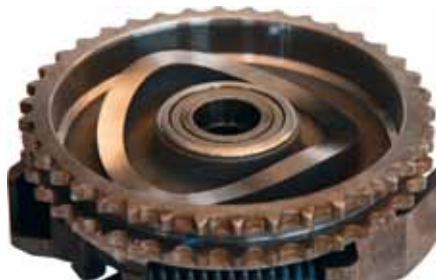
*Immaculate cam disk*

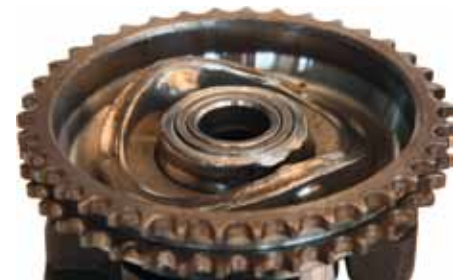
If the cam disk is worn, the cam roller of the cam follower starts to “jump”, gains notches as a result of the impact and causes rattling noises. In the worst case scenario, the feed roller can fall apart and the individual parts can get in to the primary drive.

*Worn cam disk*

**When installing a new vacuum pump, the surface of the cam disk on the injection timing mechanism must always be checked as well.**

If the cam disk is damaged or worn, the injection timing mechanism must also be replaced, as the new vacuum pump will otherwise be damaged after just a short mileage.

**The sliding surface of a worn cam disk must never be ground or polished.**

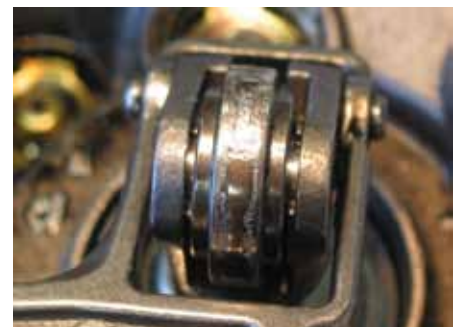
*Damage: Cam roller with pittings due to worn cam disk.*

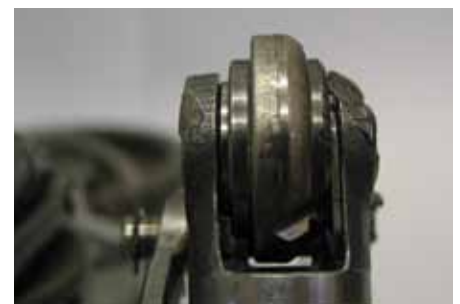
The sliding surface has a defined surface roughness, which is required for a non-positive connection with the cam roller. If the sliding surface is polished or ground, it is possible that the impeller will no longer turn with it. This will result in the impeller being worn on just one side. The chips generated by the friction then cause more damage.

*Damage: one-sided wear on the cam roller*

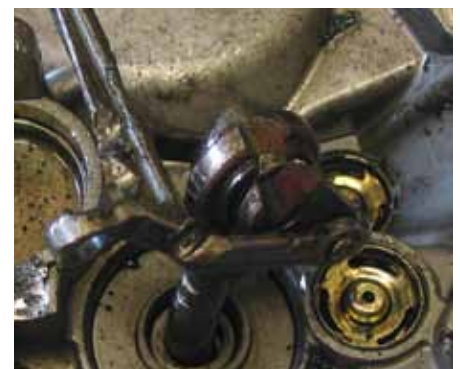
*Damage: Completely destroyed cam follower*
