**07.3 Mechanical/electronic gasoline injection system
(KE injection)**

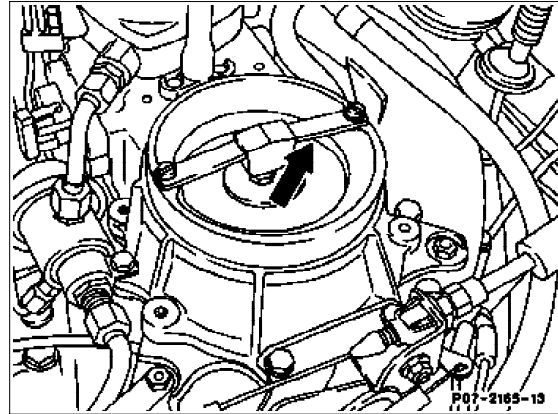
Engine difficult to start when warm

Excessively rapid pressure drop results in formation of vapour bubbles in system.

- 1 Check KE injection system for leaks by connecting pressure measuring device. Run engine briefly and switch off. The pressure then drops below the closing pressure of the injection valves to approx. 2.8 bar gauge pressure. After 30 minutes the pressure must be at least 2.5 bar. If the pressure drops to a lower level, check the following points:
- 2 Check fuel pressures (07.3-120, *07-1603).
- 3 Check zero position of air flow sensor plate (07.3-245, *07-1612). The top edge of the air flow sensor plate must be aligned with the top edge of the cylindrical part of the air funnel. The measuring point is located directly below the spring clamp (arrow).

A higher position up to max. 0.2 mm is permissible.

In this position, a clearance of 1 - 2 mm must exist when the air flow sensor plate is pressed as far as the control plunger.

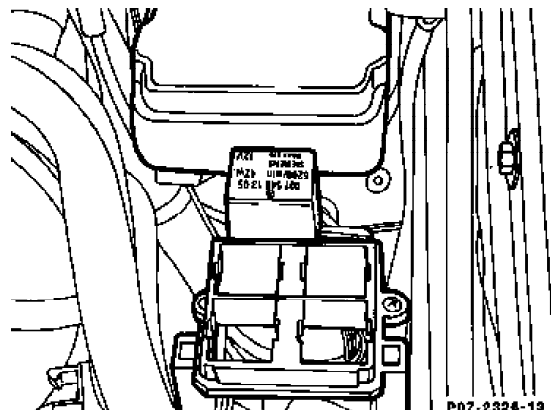
Location on engine 102.961

Fuel pump does not run or engine speed limiter not operating

Test fuel pump relay (07.3-165, *07-5792).

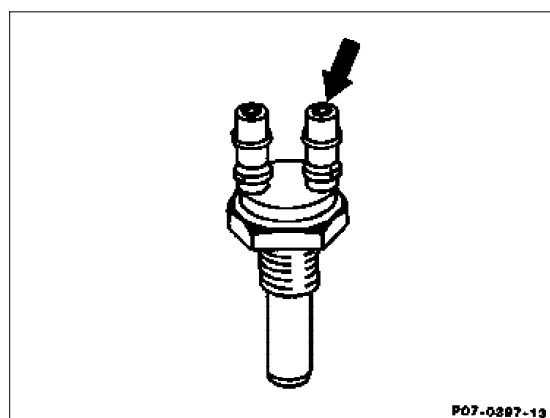
A. Engine 102.983

Push-in sleeves of coolant temperature sensor fracture.

Install coolant temperature sensor with stabilized sleeves (arrows). Standard since 11/84. Part no. unchanged.

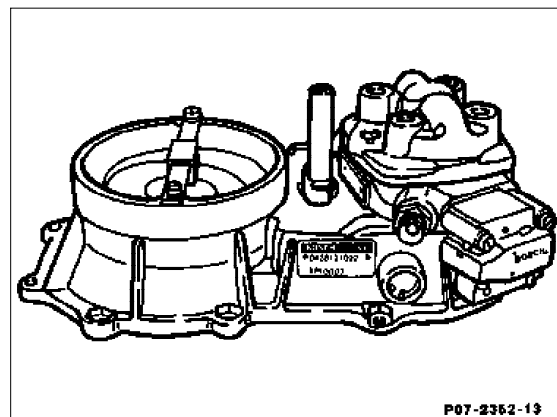
Type plate, 2-line

Engine has poor throttle response or idle speed too high

When dealing with the complaint "Engine has poor throttle response or idle speed too high", check whether the type plate on the mixture control unit has a 2-line or 3-line inscription.

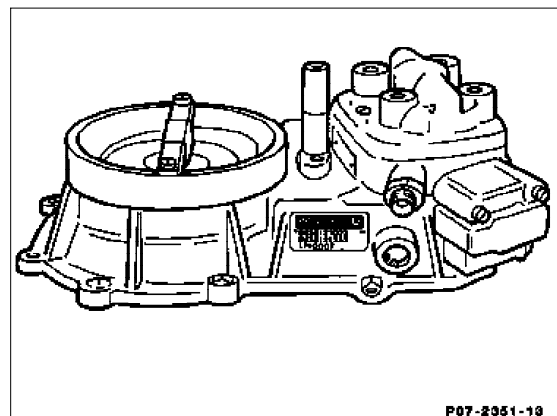
Type plate, 3-line

If this fault exists and the mixture control unit has a 3-line type plate, replace air flow sensor and fuel distributor.

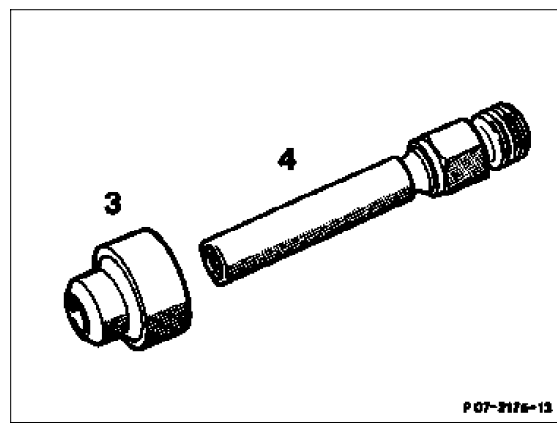
B. Engine 102

Unmetered air entering through rubber seals (3) of injection valves.

Spray injection valves with Iso-Oktan; replace rubber seals if necessary.
